Manhole Inspection Summary

Manhole # S37AA1020MH

Insp Date: **1/2/07 9:43 AM**

Location Address: **3346 OLD YORK RD**

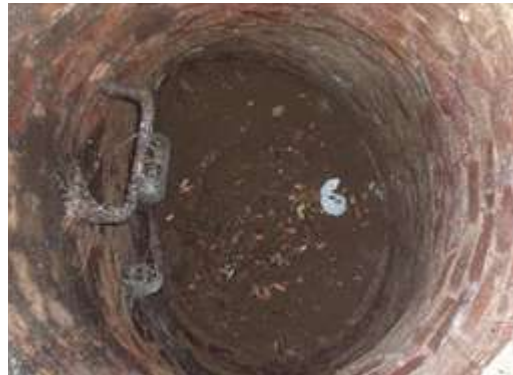
Top View

Channel debris.

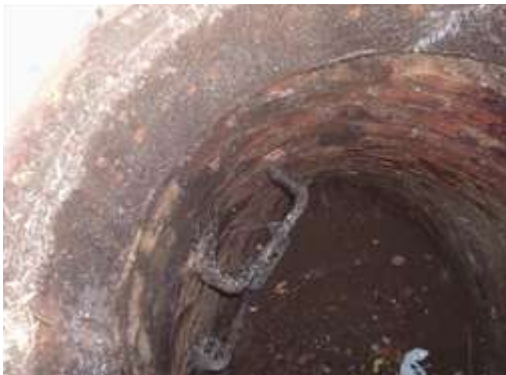
Defect

☒ **Leaks**

Condition: ☐ Sound ☐ Cracked ☐ Root Intrusion ☐ Loose Brick ☒ **Deteriorated**

Infiltration: ☐ None ☒ **Joint** ☐ Cracks ☐ Mortar ☐ Roots ☒ **Wall**

Infiltration: ☐ None ☐ Joint ☐ Cracks ☐ Mortar ☐ Roots ☒ **Wall**

Frame leaks. Adjustment deterioration and infiltration. Barrel infiltration.

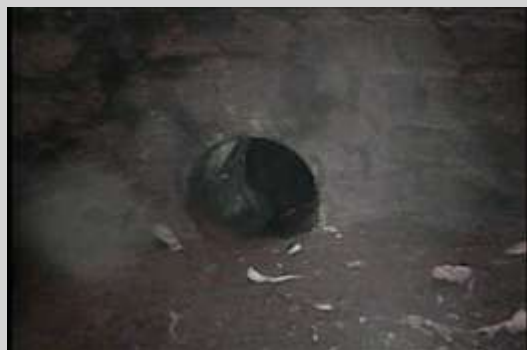
Pipe Out @ 12 O'Clock

Deposits: ☐ None ☒ **Mud** ☐ Sludge ☒ **Debris** ☐ Grease

Silt Depth: **0.5** (in.)

Deposits Extent: **Light**
